Issue 23 - Spring 2019

IMPROPER TEST KIT PRACTICES

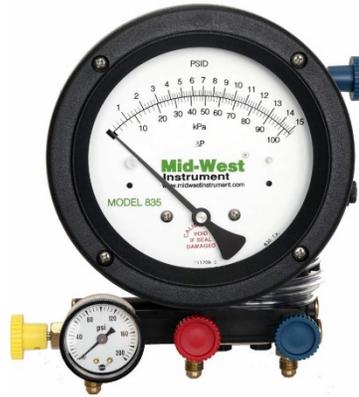
A differential pressure test kit contains an internal diaphragm connected to the differential pressure gauge that responds to water pressure. As pressure changes on one side of the diaphragm, the needle on the gauge moves accordingly. This is of particular importance when testing a DCVA, PVBA or SVBA as the test kit is only pressurized on the high side. In order for the test kit to function properly, the diaphragm must "breathe" through the low side hose connection.

Many testers find it more convenient to hold the test kit from the bottom, sometimes inadvertently covering the low side hose connection with the palm of their hand. This situation prevents the diaphragm from moving properly. Once the diaphragm is no longer allowed to "breathe" as the pressure decreases on the high side, a vacuum is created preventing the needle on the gauge to drop sufficiently to

provide an accurate reading. This discrepancy can be confirmed by noting an abnormally high differential pressure reading for a check valve, as well as a noticeable vacuum release, or "sucking sound" when the tester's hand is removed from the low side hose connection. Incidentally, this is also the reason that USC 10th Edition Field Test Procedures requires that all unused hoses must be kept at the same elevation as the test kit. If the low side hose is connected to the test kit and allowed to hang below the test kit, the difference in atmospheric pressure at the low side hose outlet will affect the gauge reading.

Proper handling of a Model 845 test kit is as important as proper test kit elevation when testing backflow assemblies. Just as improper test kit elevation can provide passing results for a component or assembly that would otherwise fail- improper hand placement when testing can also provide misleading test results. A Model 845 test kit may be held from the bottom while testing a DCVA, PVBA or SVBA provided that the low side hose connection is not covered. Many testers may find it easier to hold the test kit by the gauge face to eliminate the potential of contact with the hose connections on the bottom of the test kit.
